Hydraulic Model Investigation Of Marsh Creek Dam Principal Spillway In Contra Costa County, California

ARS-NC35
February 1976

Fred W. Blaisdell and Clayton L. Anderson¹

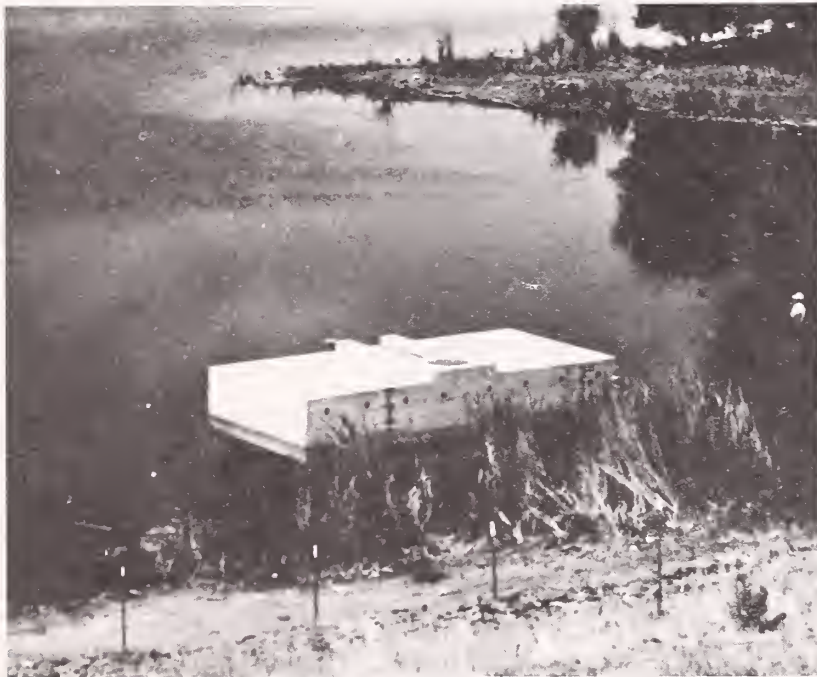
FIGURE 2.—Inlet.

A section through the principal spillway is shown in figure 1. The dimensions are “as built.” In plan the barrel is slightly curved to follow the sandstone foundation with minimum excavation. Figure 2 shows the inlet and figure 3 shows the U.S. Bureau of Reclamation Type VI energy dissipator at the conduit exit.

The studies were concerned primarily with the hydraulics of the inlet structure shown in figure 2. The dimensions of the drop inlet pertinent to this study are shown in figure 4.

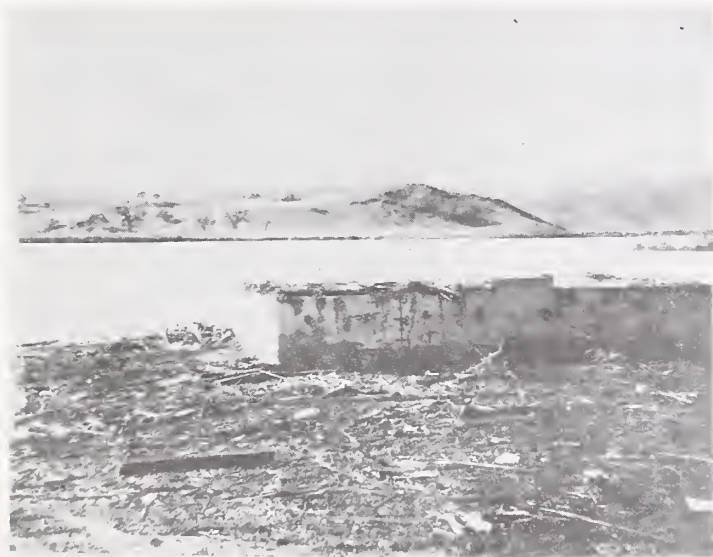
1. At 10:10 a.m. the water surface at principal spillway was indicated to be (-) 0.1', by the painted scale on the hood, below the crest which is supposed to be constructed at elevation 168.0'. An audible roar of falling water could be heard even when inside the recorder building on top of the dam. All of the (8) 4" ϕ vent holes on the north face of the spillway appeared to be partially to completely plugged with debris. (Ref. photo No. 1).

Photo No. 1.—1/27/69 w/s [water surface] at inlet indicated at —01 10:10 a.m.

a. Install a system of trash-racks that would ensure free passage of air or water through the vent holes in the hood at all pond levels. . . .

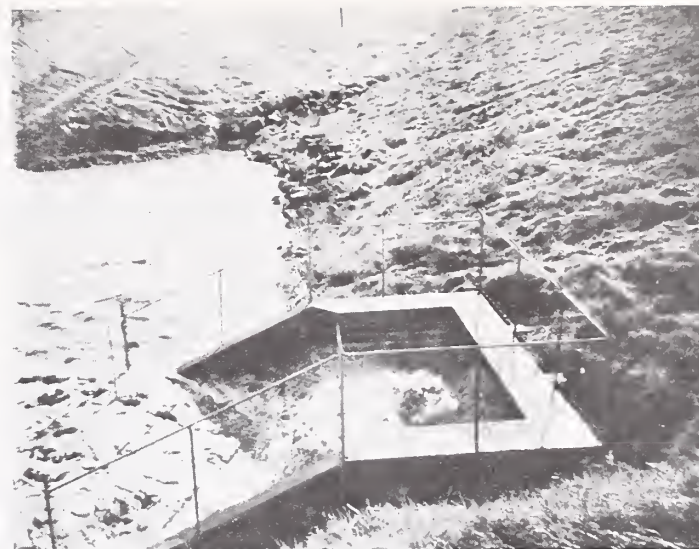
2. At 10:15 a.m. the discharge in the energy dissipator was turbulent and it appeared that the 4.5' \times 4.5' spillway tube was flowing full. (Ref. photos No. 2 & 3).

Photo No. 2.—1/27/69 10:15 a.m. [No air expelled.]

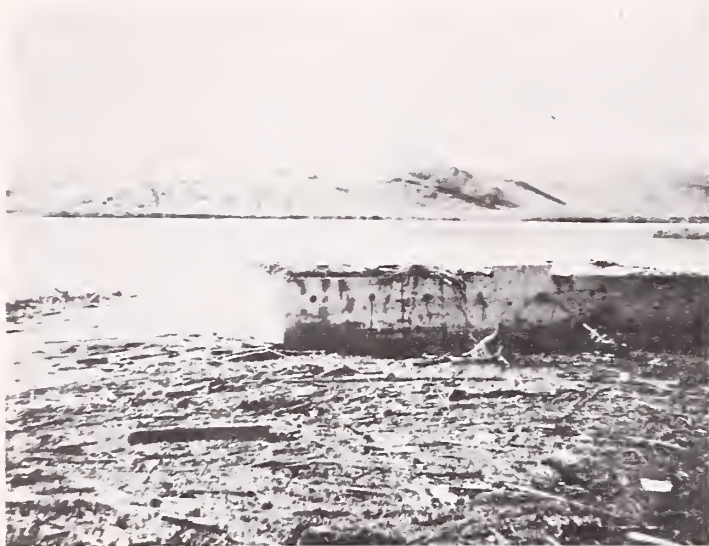
3. At 10:25 a.m., while in the recorder building, I realized that the audible flow had ceased. I now estimate the time from when I last consciously heard the flow to when I realized it had stopped to be no more than a few minutes. At 10:32 I recorded the water surface at the spillway hood to be an indicated (-) 0.2'. (Ref. photo No. 4). Later scrutiny of the photo indicated that several of the vent holes appearing partly plugged on photo No. 1 were open in photo No. 4.

Photo No. 4.—1/27/69 10:32 a.m. Spillway at -0².

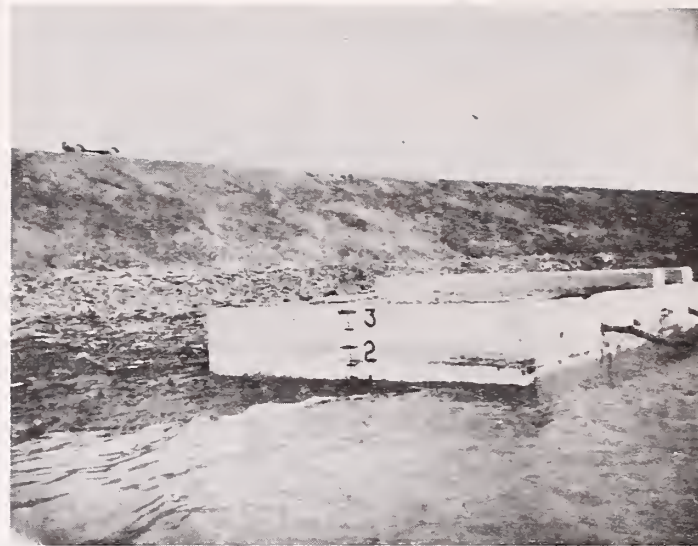
1. Photo No. 6 shows the indicated water surface to be 1.0' over the principal spillway crest. A very slight audible sound was heard at the spillway which could not be readily heard from on top the dam. Note the debris in some of the 8 vents on the south face of the hood.

Photo No. 6.—1/29/69 West face of Princ. Splway [principal spillway].
w/s [water surface] appeared to be at indicated 1⁹ above crest elevation.
2:30 p.m.

10. On January 29, the pond level was at elevation 169.0 (one foot above crest). The slightly audible sound was indicative of the control being at the crest (weir control). The flow was probably close to 100 cfs. The barrel, however, was flowing practically full and the depth of flow over the end sill of the dissipator estimated from one of the pictures taken by Mr. Jewett was about 4.3 ft.

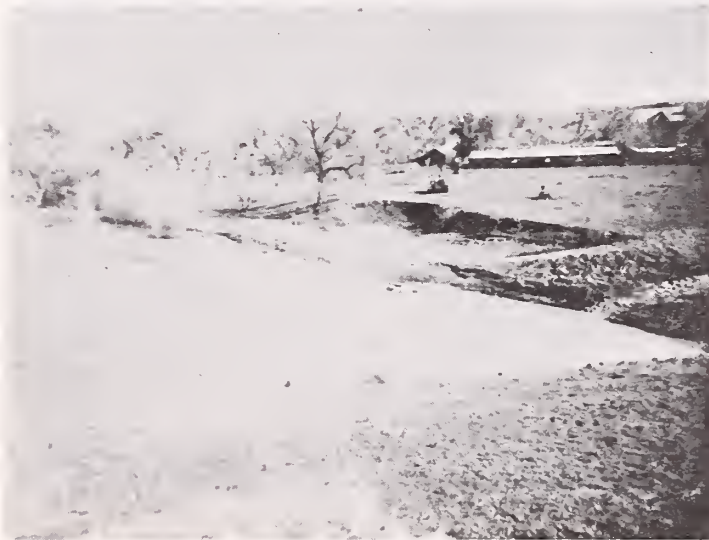
4. Although hardly discernible, photo No. 5 shows the outflow area to be tranquil with no visible flow from the dissipator.

Photo No. 5.—1/27/69 10:32 a.m. Spillway stopped flowing.

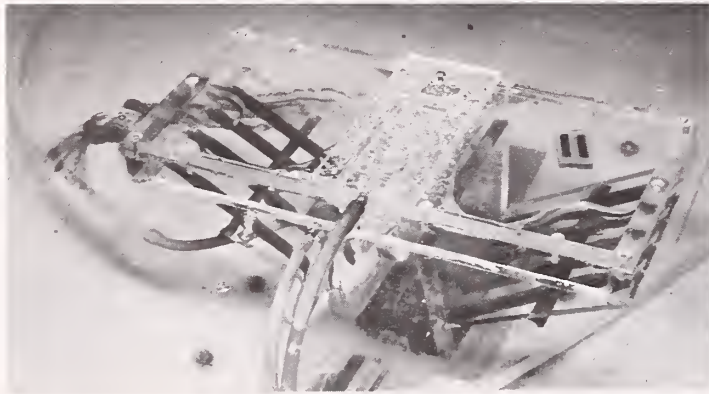
Figure 10.—Vents open, head 2.95 ft, discharge 457 c.f.s. Small vortex at left upstream corner of antivortex plate, air trapped under upstream outside corners of antivortex plate, splash on underside of antivortex plate over drop inlet, weir control, drop inlet partly full, air being entrained by nappes.

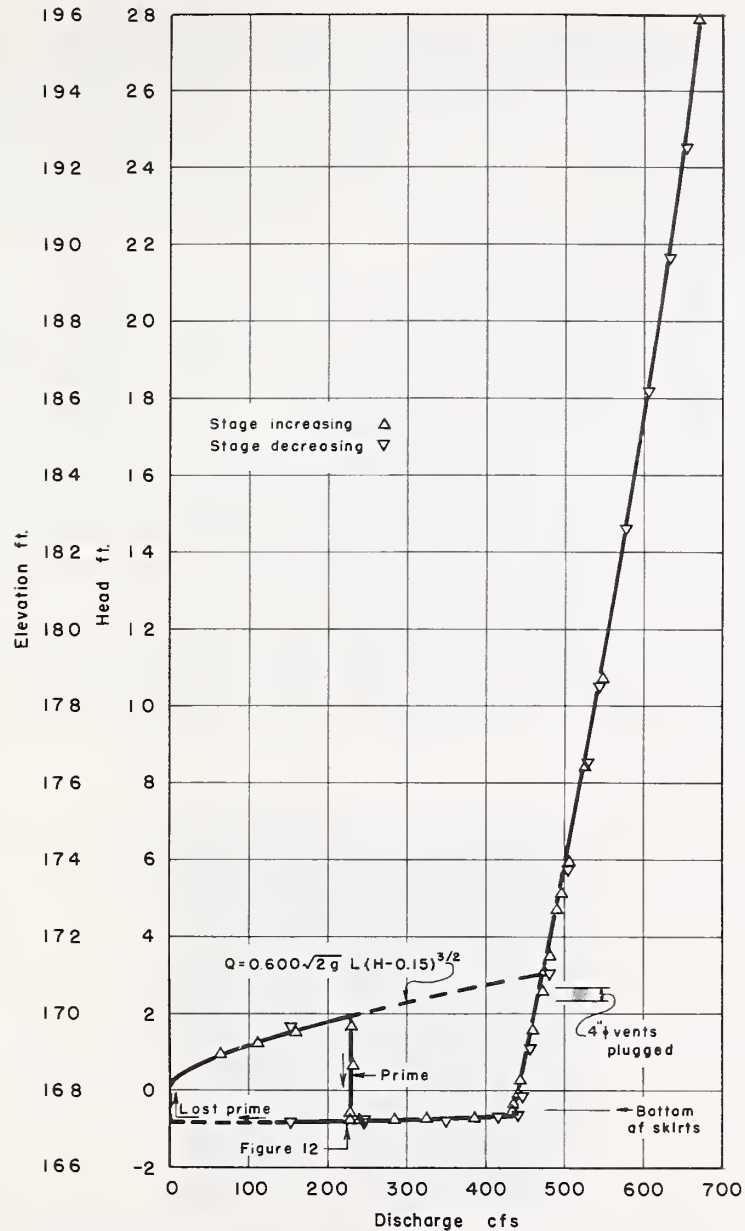
As the discharge increased from 229 to 433 c.f.s., the drop inlet gradually filled and the air entering under the skirts gradually decreased. One of the weir nappes clung and the other sprung free.

There were surface vortices at the ends of the antivortex plate for heads between 2.5 and 11 ft. Air bubbles were trapped under the upstream outside corners of the antivortex plate at heads exceeding 4 ft. Air was trapped over the drop inlet at a discharge of

Figure 11.—Model head-discharge relationship: vents closed.

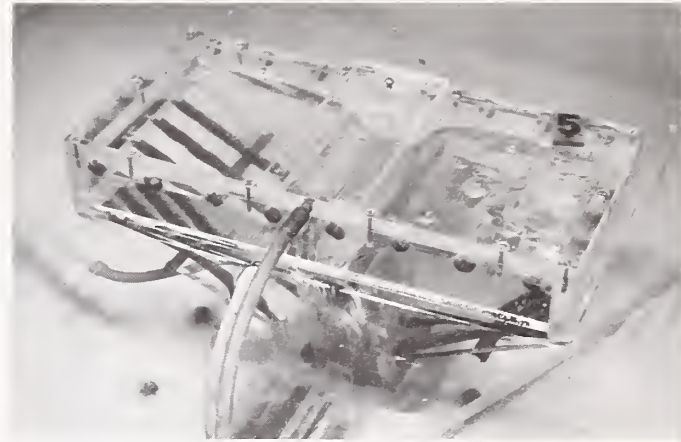
FIGURE 12.—Vents closed, head -0.8 ft, discharge 229 c.f.s. Siphon-regulated flow, air entering from under antivortex plate skirt, drop inlet partly full.

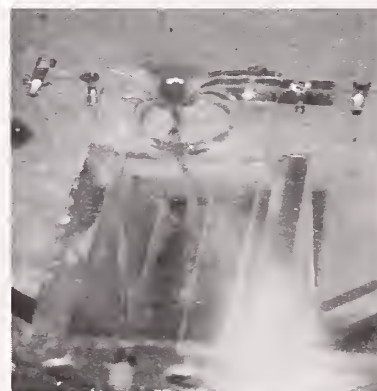
There was an air-entraining vortex over the open manhole. The fluctuating air core extended from the water surface, through the manhole, and through the height of the drop inlet (fig. 14). The vortex core admitted air to and the air was transported through the barrel. No effect of the air on the spillway capacity could be detected. These air-entraining vortices were observed at heads ranging from about 5.0 to 8.5 ft, which correspond to depths of about 1.0 to 4.5 ft over the top of the antivortex plate. No vortices were observed and the pool surface was quiet at heads exceeding 8.5 ft.

Figure 14.—Vortex with fluctuating air core extends through manhole and drop inlet and admits air to barrel, head 5.9 ft.

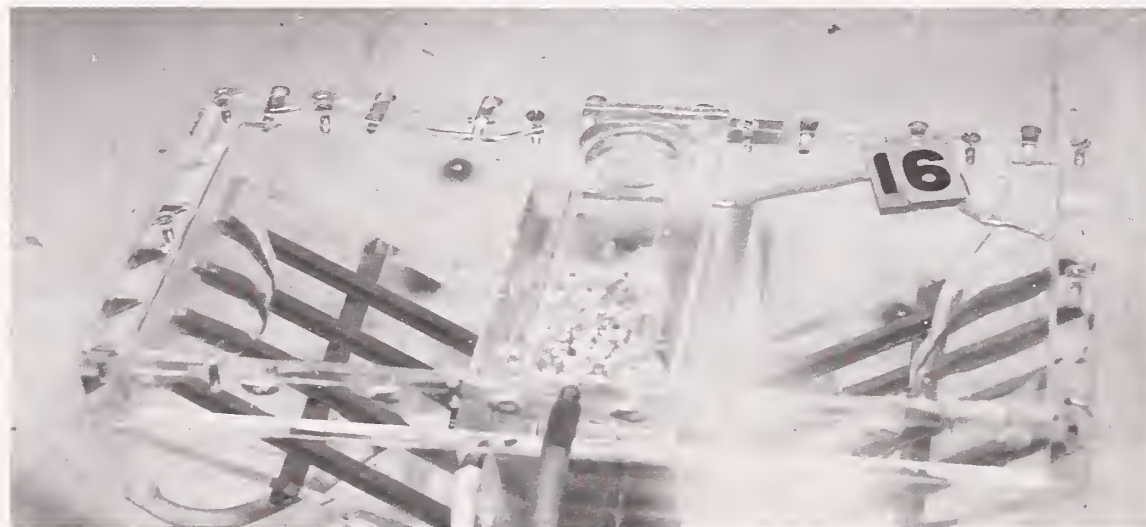
Figure 20.—Little loss in head between the headpool and drop inlet. Water is standing in the manhole opening. The head on the spillway crest is 3.7 ft, 0.9 ft above the bottom of the antivortex plate. The pressure at the center of the antivortex plate is 0.5 ft. The pressure drop between
